CASE REPORT - EB-06-SF-147

Subject: Harpal Singh S&L Trucking

IX at Mt. Vaca.

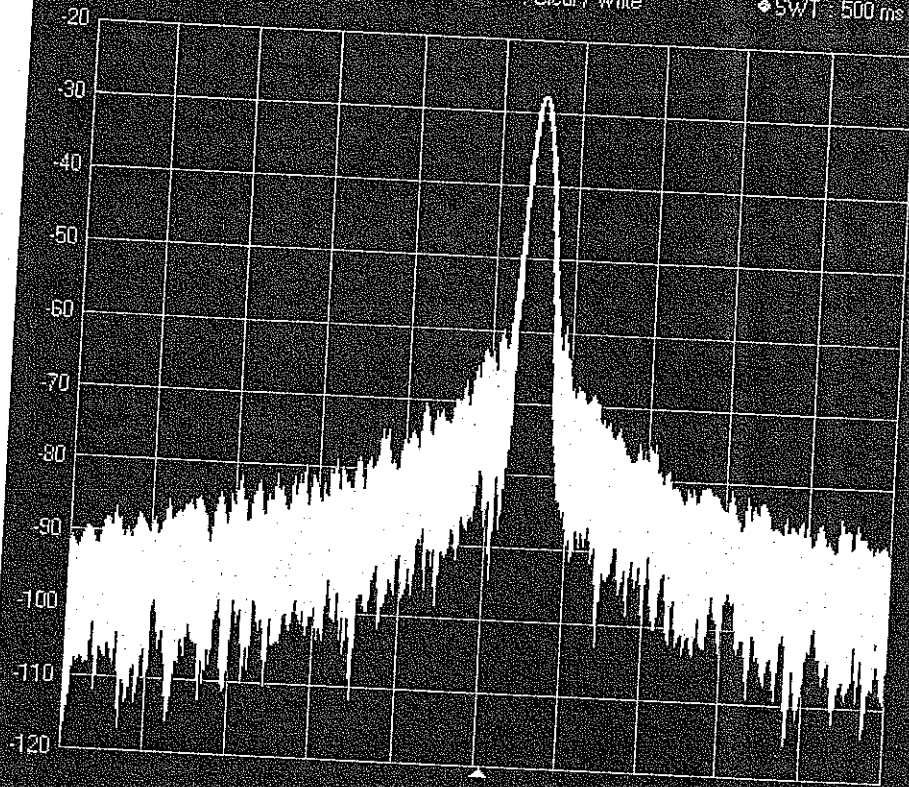
dBm Ref Level: -20 dBm
Ref Offset: 0.0 dB

Detector: Auto Peak (Auto)
Trigger Mode: Free Run
Trace: Clear / Write

RBW: 3 kHz
VBW: 3 kHz
SWT: 500 ms

Name	Trace
Ref Level	Analyzer
Range	20 dBm
Result	10 dB/div
Averaging	...

Channel Table	Status
Channel	...
Center Frequency	459.27839 MHz
Frequency Offset	0 Hz
Span	200 kHz
Ref Offset	0.0 dB
RF Attenuator	0 dB
Preselector	Off
Dynamic Range	Low Distortion
RF Input	50 Ohm
Preselector	Not connected
RBW	3 kHz
VBW	3 kHz
SWT	500 ms
Trace Mode	Clear / Write
Detector	Auto Peak (Auto)
Trigger Mode	Free Run
Trigger Level	...
Trigger Delay	...
Upper Limit	...
Lower Limit	...
External Reference	Disabled
Transducer	...
Transducer (dB)	...
Date	9/20/2006
Time	1:47:49 PM
Instrument	FSH03-100930

Analyzer Start Frequency: 459.17839 MHz Stop Frequency: 459.37839 MHz
Center Frequency: 459.27839 MHz Span: 200 kHz

Signal continues to drift. Used portable s/a with 450 MHz yagi antenna and made spectrum plots of signal. With handheld s/a same results for location of source, strongest signal seems to be from the left side of the house. Left contact notice at residence, hung on gate. Received call from Mr. Singh. Mr. Singh said that people have been to his house three or four times and he did not want to be bothered anymore. He had children, friends and relatives at his house and did not want them to be disturbed by our actions. He just wanted this to be over with and didn't want to be bothered. I told him that we needed to locate the source and get it off the air to eliminate the IX and then we would not need to disturb him any longer I explained what I knew about the problem thus far and asked that he allow me to locate the source and he refused to allow me to come to his house and do that. He told me to check with the sat TV service to have them fix it. I asked about his sat TV service and told him [REDACTED] had checked and said it was disabled in 2003, and he said he currently has service. Returned to house and DF'ed signal again and made plot.log. Saw neighbor, to the left of the subjects house, come out of house to get mail so I attempted to make contact with him, he would no answer my knocks at the door or door bell ringing. Note that signal drifted from about 457.3 MHz to 457.7 MHz. Received template for citation. Drafted citation and sent to WR council.

Processed plot.log and s/a plots, printed spectrum plots.

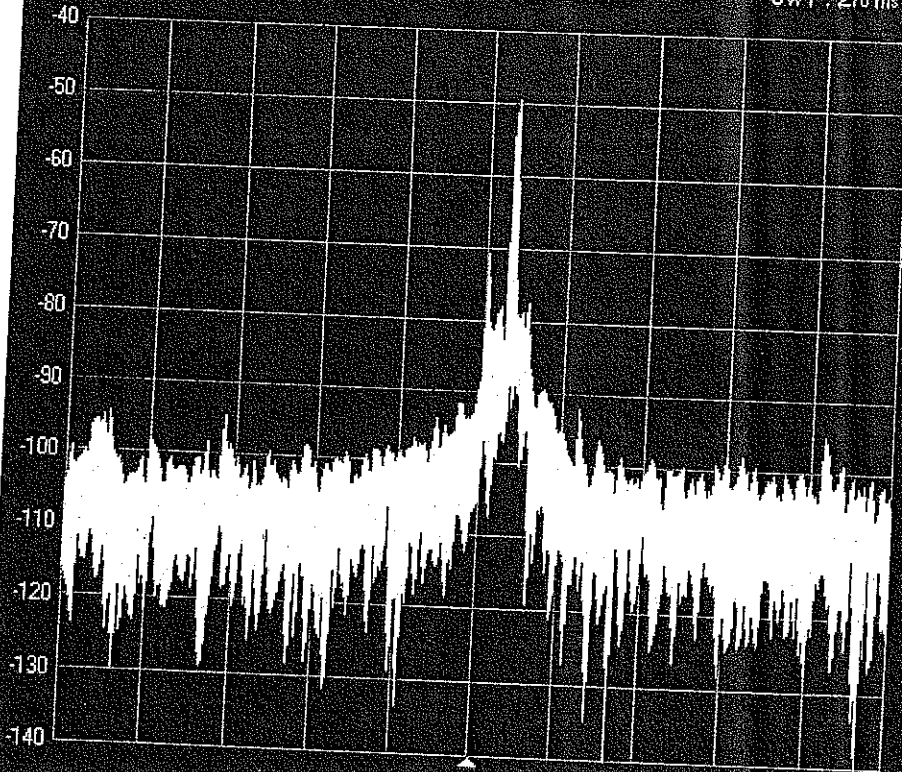
RBW : 3 kHz
VBW : 3 kHz
SWT : 278 ms

Name	Trace
Ref Level	: -40 dBm
Range	: 10 dB/div
Result	: ...
Averaging	: ...

Status	
Channel Table	: ...
Channel	: ...
Center Frequency	: 457.28103 MHz
Frequency Offset	: 0 Hz
Span	: 500 kHz
Ref Offset	: 0.0 dB
RF Attenuator	: 0 dB
Preamplifier	: Off
Dynamic Range	: Low Distortion
RF Input	: 50 Ohm
Preselector	: Not connected
RBW	: 3 kHz
VBW	: 3 kHz
SWT	: 278 ms
Trace Mode	: Clear / Write
Detector	: Auto Peak (Auto)
Trigger Mode	: Free Run
Trigger Level	: ...
Trigger Delay	: ...
Upper Limit	: ...
Lower Limit	: ...
External Reference	: Disabled
Transducer	: ...
Transducer (dB)	: ...
Date	: 2/26 1995
Time	: 1:52:37 AM
Instrument	: FSH03 100930

Analyzer Start Frequency : 457.03103 MHz Stop Frequency : 457.53103 MHz
Center Frequency : 457.28103 MHz Span : 500 kHz
